# **Living Shoreline Case Study**

### Lewes Ball Field, Lewes

### **DNREC Wetland Monitoring and Assessment Program**

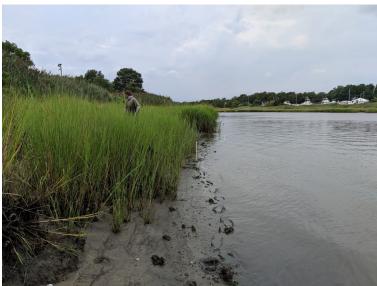
June 2021

Coir log and shell bag installation on expansion
