# Mispillion Living Shoreline

Milford, Delaware

# Partnership for the Delaware Estuary

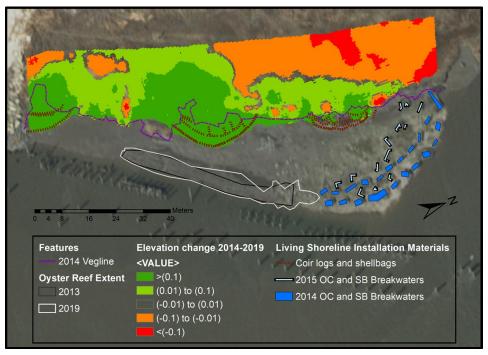
Site-wide 2014-2019 elevation change as measured with annual RTK-GPS grid survey (3m<sup>2</sup>), relative to the positions of the installed materials (pre-augmentation)

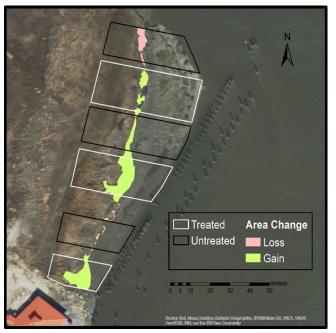
Salt marsh area change 2014-2019 between treated and control areas.

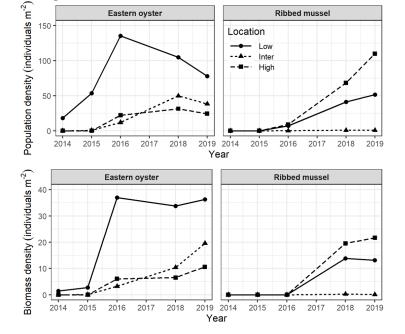
Changes in shellfish population and biomass density at 3 positions along the living shoreline—on the breakwaters (low), along the marsh edge materials (high), and between on the bare substrate (inter)
