Living Shoreline Case Study

Seagrass Plantation Living Shoreline, Dagsboro

Douglas Janiec, Sovereign Consulting Inc.

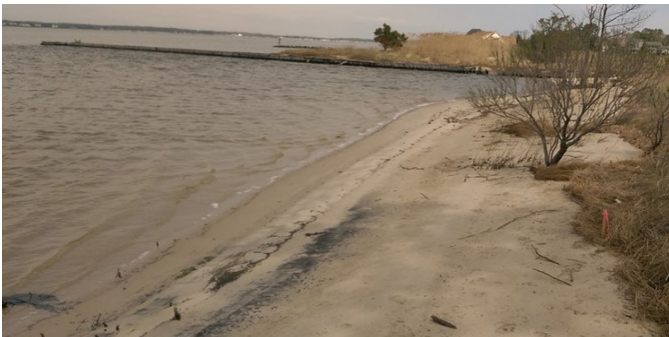
Pre-installation May 2018

Rapid shoreline scouring resulting in loss of beach, marsh, and horseshoe crab spawning habitat

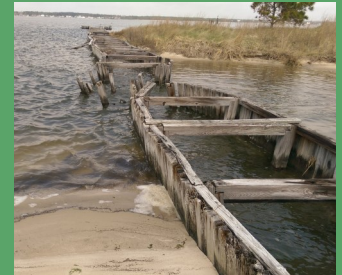
May 2018
breached abandoned sluice

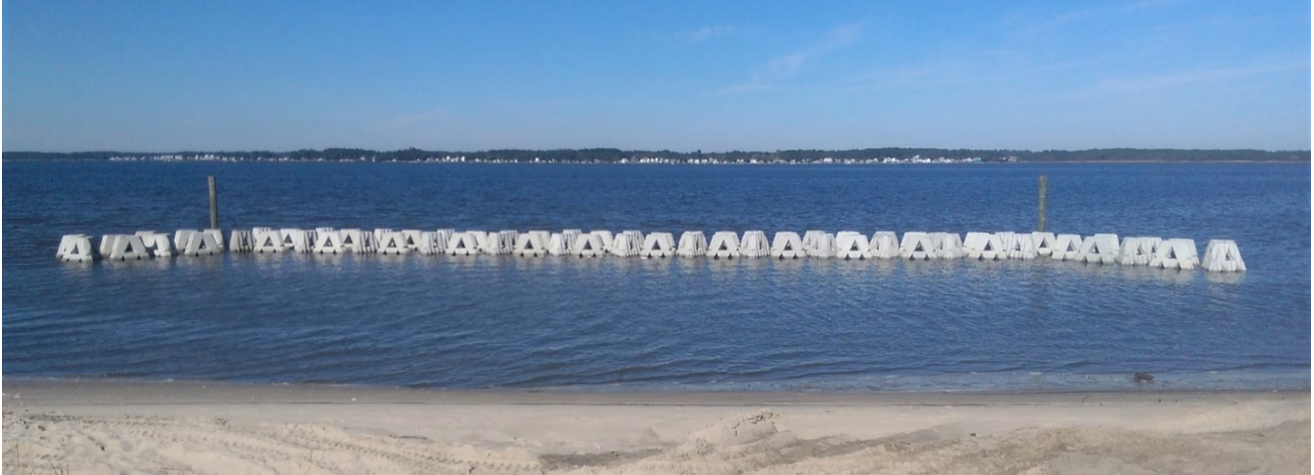
May 2019

WADs after approximately 7 months

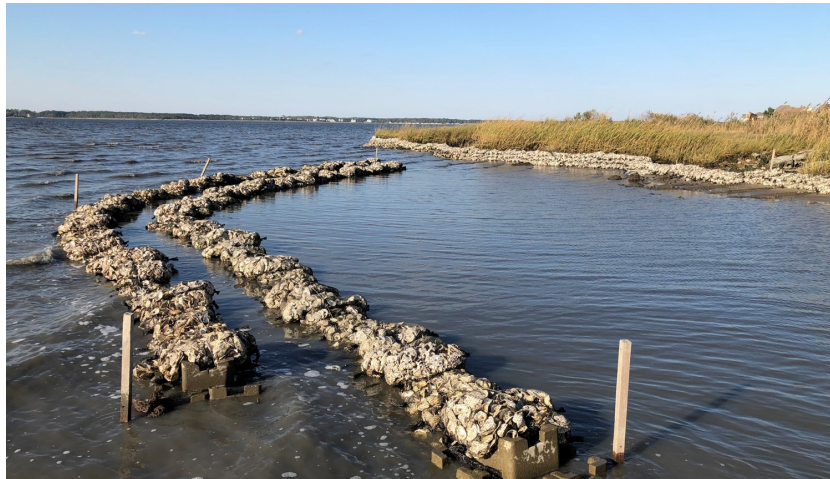
October 2018

Oyster castle/shell bag reef at blowout tide

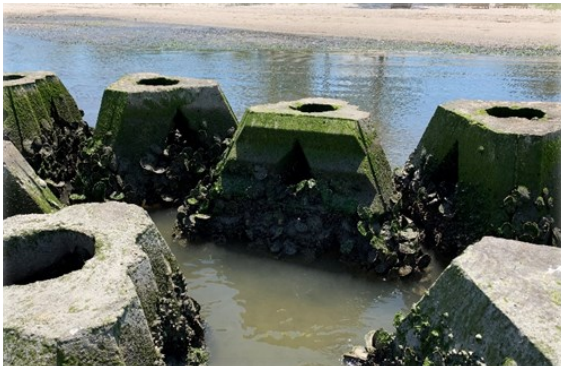
September 2022
Oyster recruitment on WADs

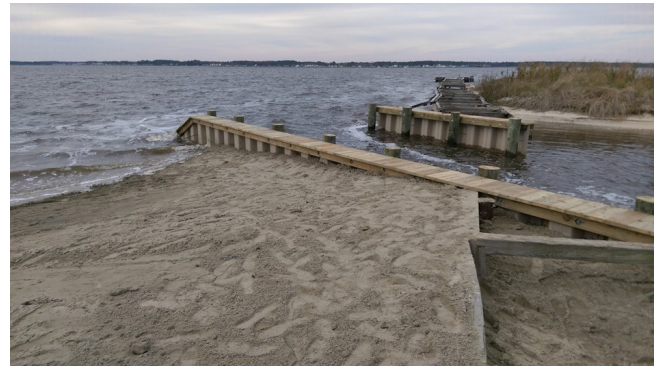
October 2018
Sluice retrofit
