Living Shoreline Case Study

Sassafras Landing, Assawoman Wildlife Area, Frankford

Chris Pfeifer, Integral Consulting

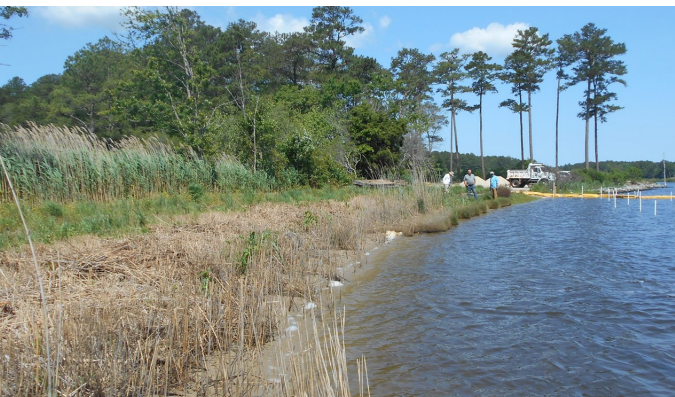
Pre-Installation June 2019

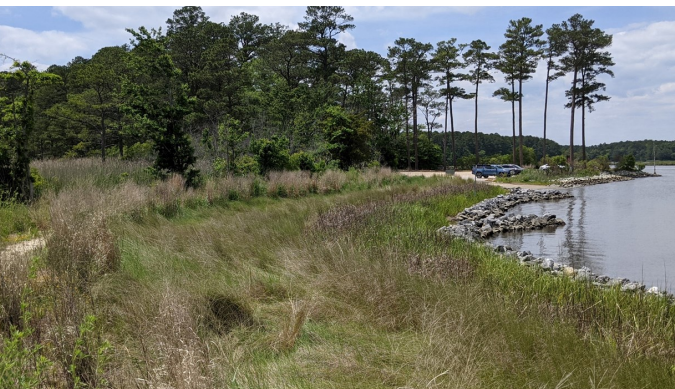
Post-Installation June 2021

- Project continues to meet goals and objectives
- Restored and enhanced 0.3 acres of tidal marsh
- Shoreline remains stable and has completely revegetated with no significant erosion
- Withstood several coastal storms and nor'easters without damage; accretion noted
- Estimated to remove 62lbs. of nitrogen and 3lbs. of phosphorus annually
- Public access, high visibility, and educational signage help project fulfill its demonstration objectives

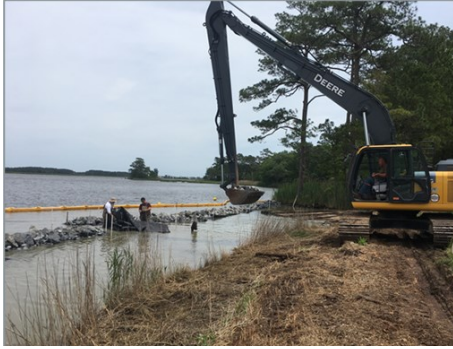
June 2019
Constructing toe sills

- ~380 linear ft. of rock toe sill in 5 segments parallel to shoreline ~30ft. beyond mean low water
- 2-3ft. high sills (1.5:1 side slopes) to +1.0 NAVD88 (0.5' above MHW) built from R4/R5 quarry stone
- 5ft. rock-lined gaps stabilized with oyster shell bags between sill segments
- Washed concrete sand (imported) placed between existing shoreline and sill to raise bottom elevation
- Backfill graded to target elevations to create low marsh and high marsh tidal hydrology
- ~5,200 plugs of smooth cordgrass (*Spartina alterniflora*), salt meadow hay (*S. patens*), and switchgrass (*Panicum virgatum*) installed by volunteers

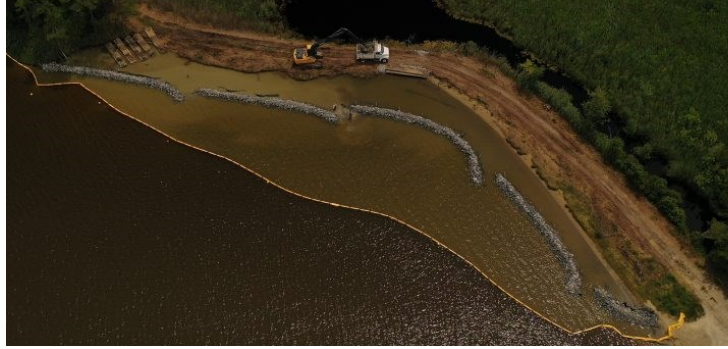
June 2019
Completed toe sills before sand backfill

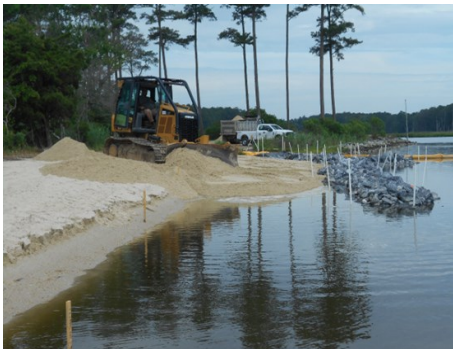
June 2019
Backfilling and grading

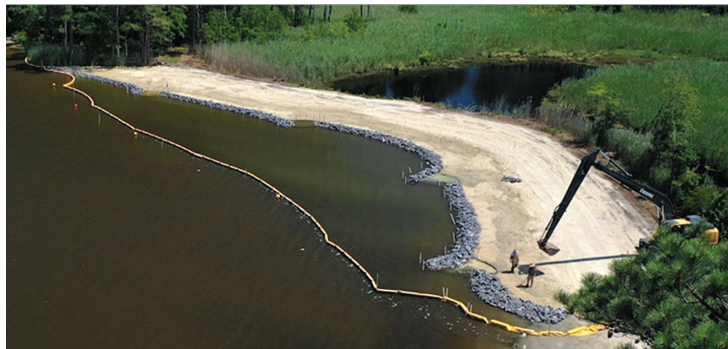
June 2019
Graded shoreline before planting

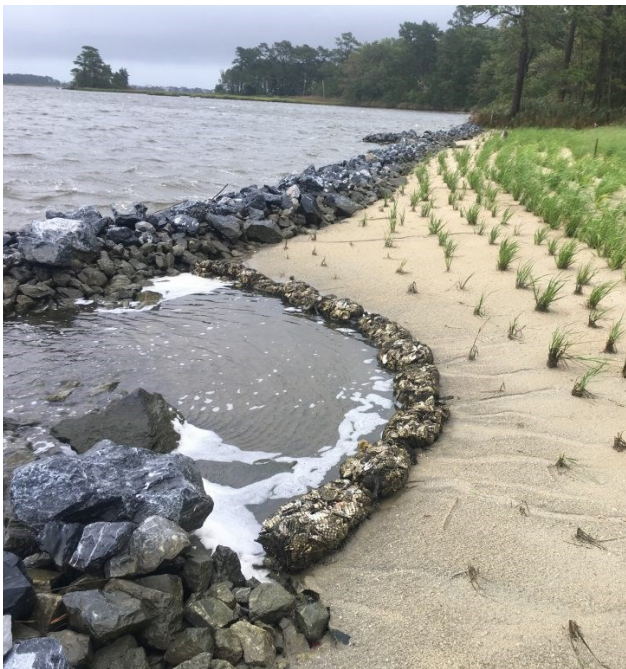
August 2019
Bagged oyster shells stabilizing
gap between segments

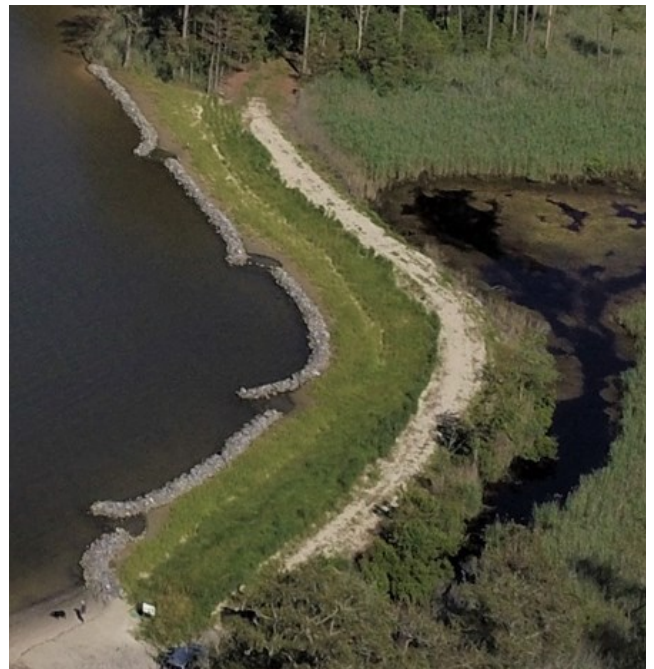
June 2020
Aerial view of site during second
growing season
