Living Shoreline Case Study

Delaware Botanic Gardens, Dagsboro

Douglas Janiec, Sovereign Consulting Inc.

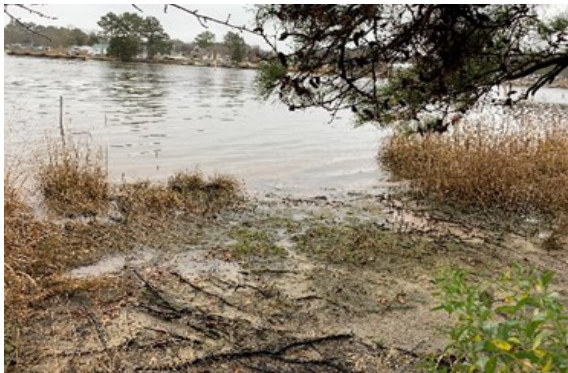
Pre-installation December 2019

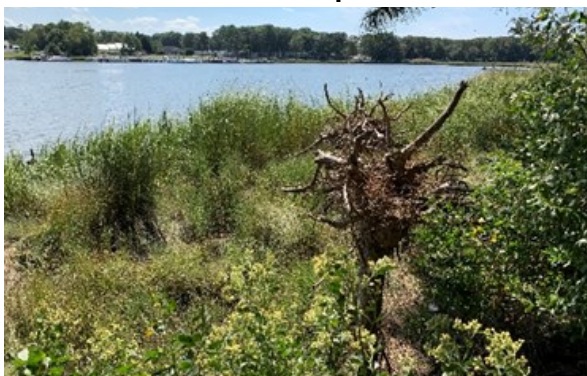
Post-installation September 2022

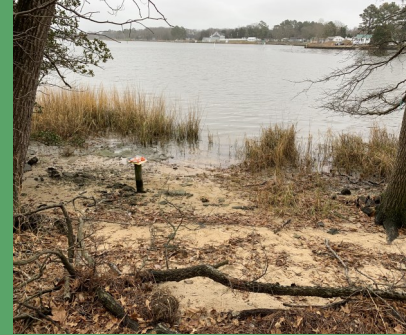
December 2019

Chronic fringe marsh loss

- Slow shoreline migration due to a combination of sea level rise, shading, invasive species, and acute storm events; irregular, thin marsh edge

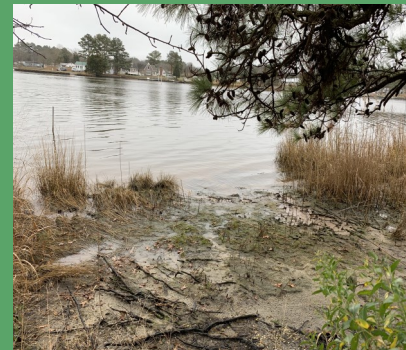
December 2019

Chronic fringe marsh loss

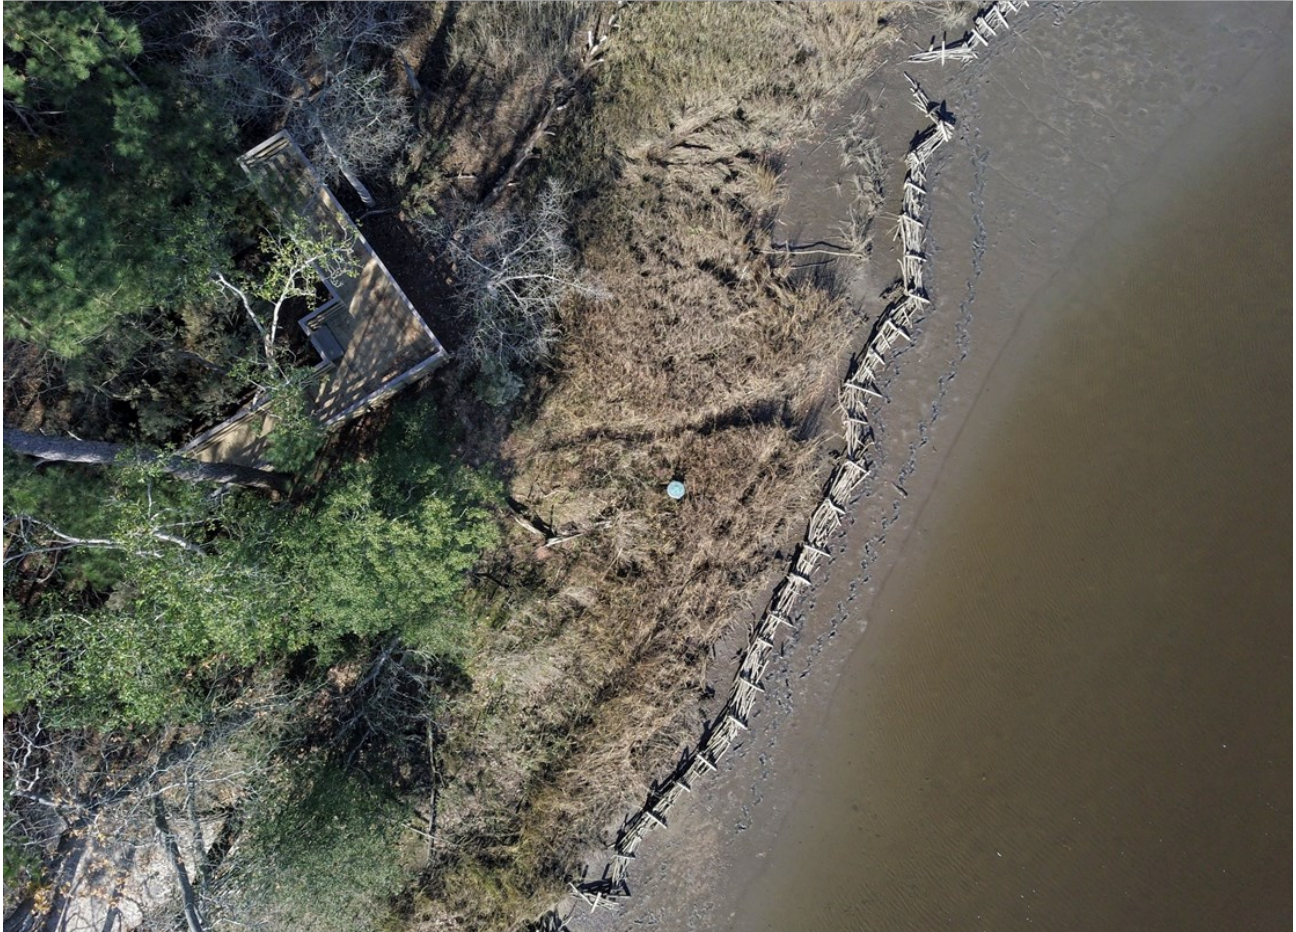
Fall 2021

Drone photography of portion of site showing ABT and platform

- Unexpected results: The horizontal branches in the ABT had some settling sufficient to create some space in the upper portion of a few of the ABT segments. This was a combination of branches packing together tighter, some sinkage in the muck substrate, and a few branches rotting. Additional branches were added to reestablish branch densities through the entire structure. This was performed once in August 2021 and to a much lesser extent in August 2022
- A small section of the ABT required repair due to a large tree falling on it from uplands
- For future installations, reduce spacing of ABT anchoring sets by about 20% to facilitate cross branch installation
- Noteworthy recovery results: The marsh edge is clearly migrating towards the ABT as projected. In some locations, vegetation is already (as of 9/2022) growing through the ABT

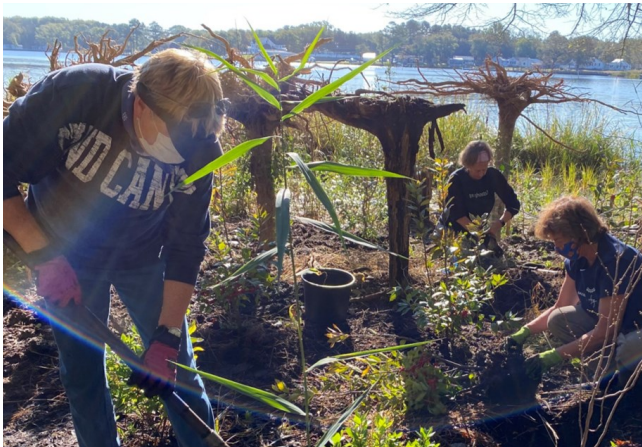
Inverted root wads with
new shrub plantings

- Anchored Branch Toe (ABT)
- Localized marsh platform nourishment and plantings
- Inverted root wads
- Upland, anchored branch revetment with dense matting of briar used in place of filter fabric
- Viewing platform for outreach and education

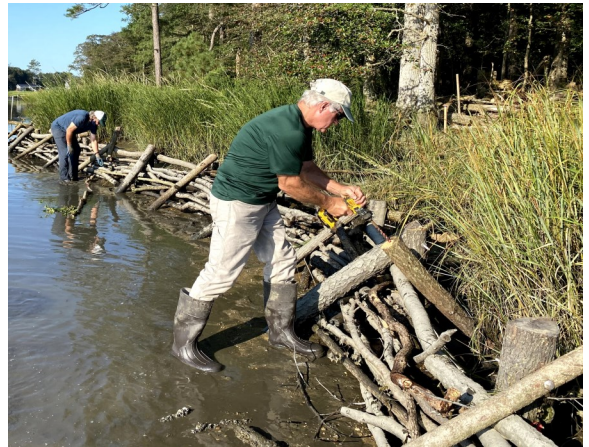
Summer 2020
Construction of ABT

- Optimal reuse of natural materials: ABT and revetment constructed from trees from on-site, cleared while constructing walking paths; trees connected with stainless steel bolts, washers, and nuts
- Plants acquired from local native plant nurseries
- Viewing platform constructed from retail marine lumber
