Living Shoreline Case Study

Read Avenue Retrofit, Dewey Beach

Delaware Center for the Inland Bays

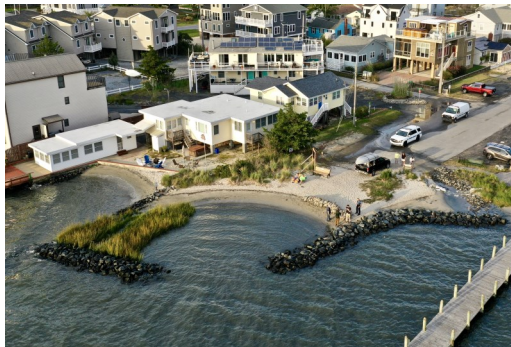
Pre-installation September 2019

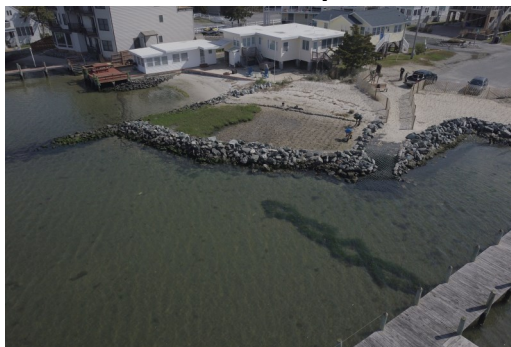
Post-installation April 2020

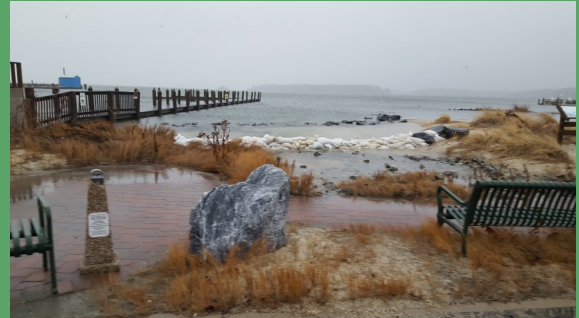
January 2017
Surcharge flooding

- West terminus of Read Ave. subject to stormwater and tidal flooding
- Area an important recreation area

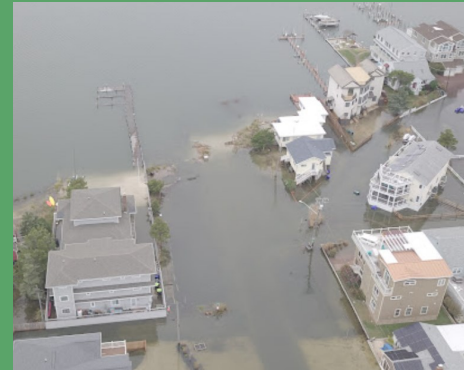
October 2019
Sunny-day flooding

- Medium/high fetch energy
- Medium boat wake
- Upland drainage flows into bay; surcharge and sunny-day flooding occur
- Public bay access area

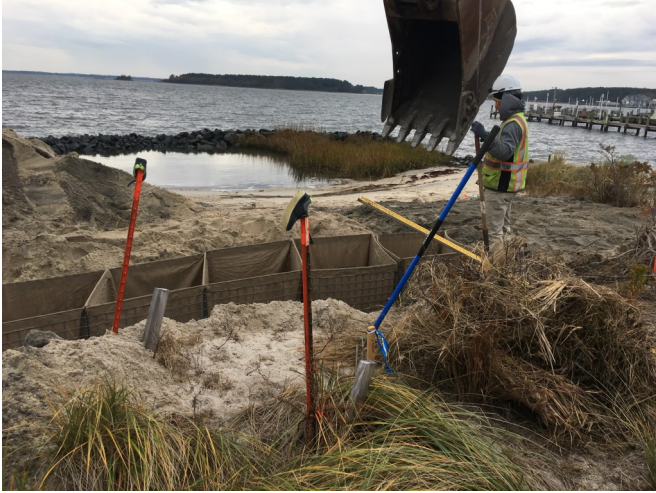
Winter 2019
Hesco barriers installed

- Concrete box vault assembly with tide gates landward of bay
- Hesco barriers used to reinforce dunes
- Oyster Bag reef set at MLW
- Shell bags, rock used for marsh toe
- Sand for fill on dune, marsh

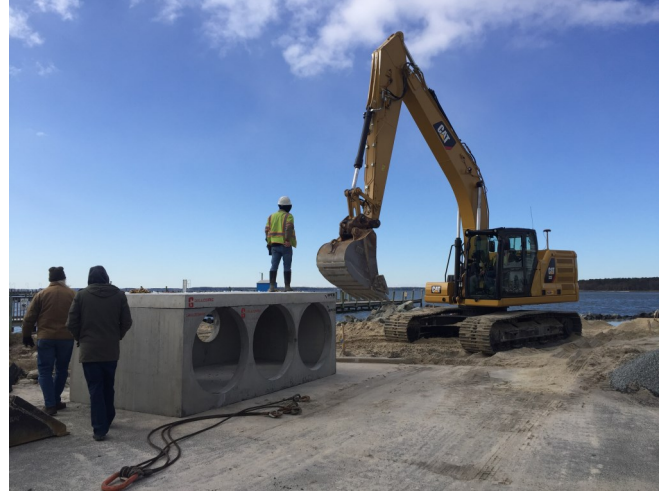
Winter 2019
Box vault installed

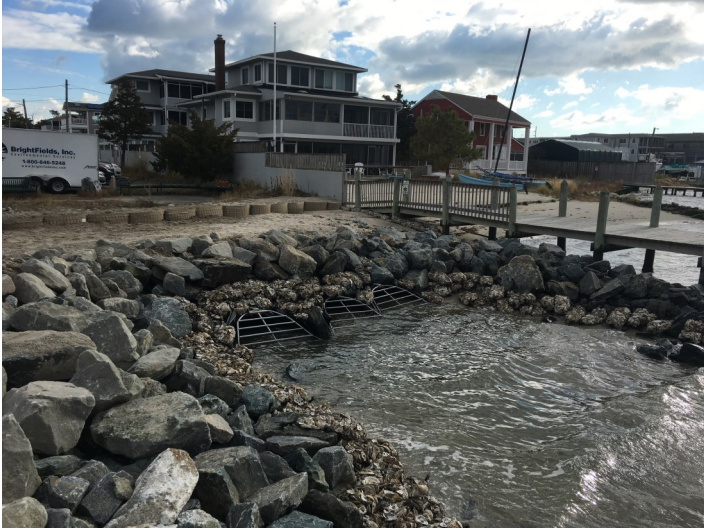
Fall 2019
Completed tide valve assembly

- Connection from upland urban drains to tide gates allows for drainage of stormwater while preventing surcharge flooding from the bay
- Dune placed to 3.5ft. above MHW to prevent high tide/sunny-day flooding onto Read Ave.
- Creation of salt marsh
- Oyster Bag reef located offshore to dissipate fetch energy
- Access path for paddle craft access to the bay

- Regular maintenance of tide gates required

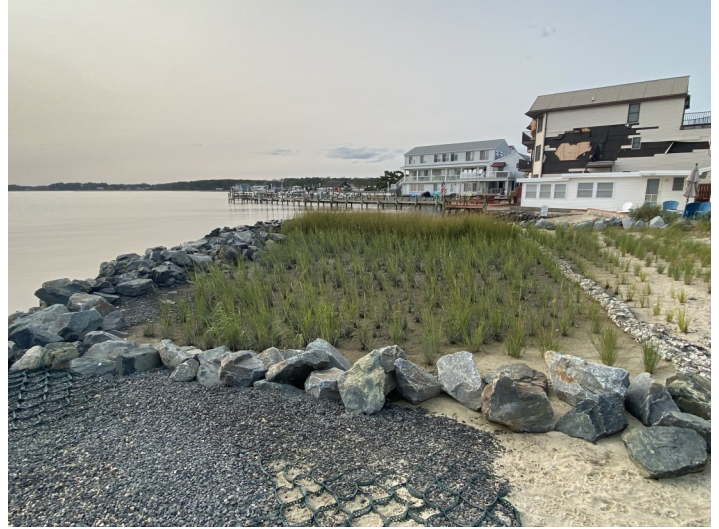
Summer 2020
Planted salt marsh

- .4 acres of wetland created
- Addresses bay flooding less than 3.5ft. below MHW
