# **Living Shoreline Case Study**

### Lewes Ball Field, Lewes

### **DNREC Wetland Monitoring and Assessment Program**

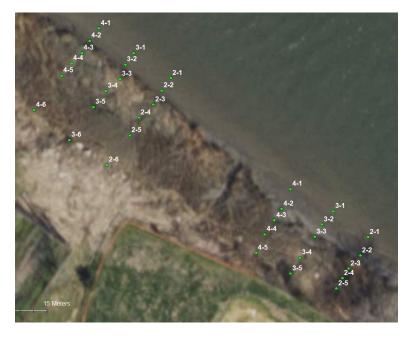
To monitor for progress three transects running parallel to the shoreline were set up prior to installation. Five monitoring points along each transect was established starting with point 1 in the water and ending with point 5 in the high marsh. Pre-installation monitoring collected baseline information to compare the effects of the treatment against

Metric	Method
Vertical shoreline position	RTK
Horizontal shoreline position	RTK
Mussels and oysters	1m plot lip counts
Mussels and oysters	Shell bag examination
Vegetative robustness	Horizontal veg obstruction
Plant species	1m veg plot cover
