Living Shoreline Case Study

Seagrass Plantation Living Shoreline, Dagsboro

Douglas Janiec, Sovereign Consulting Inc.

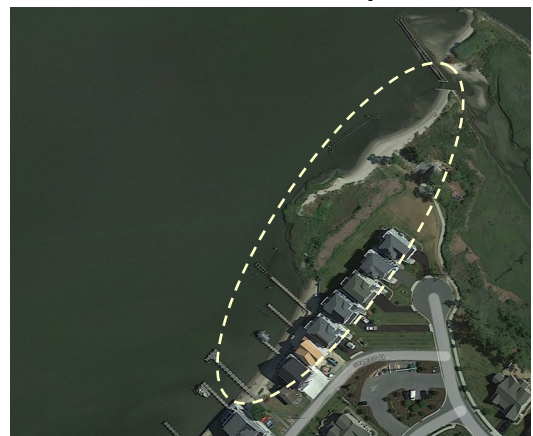
Post-installation: July 2022

- Landward of WADs, MHW line moved more than 30ft. channelward
- All installed structures and reefs remained in good condition
- Horseshoe crabs are once again spawning on the beach
- Southern beach gained vertical elevation by more than 14inches and MHW line moved channelward more than 15ft. in certain areas
- Shell bag toe stopped horizontal marsh erosion
- Successful community outreach and monitoring participation
- Project goals exceeded
